KSI: Kinzua Site Investigation

The Forensic Study of the July 21, 2003, Collapse of the Kinzua Viaduct
Jonathan McHugh, P.E.

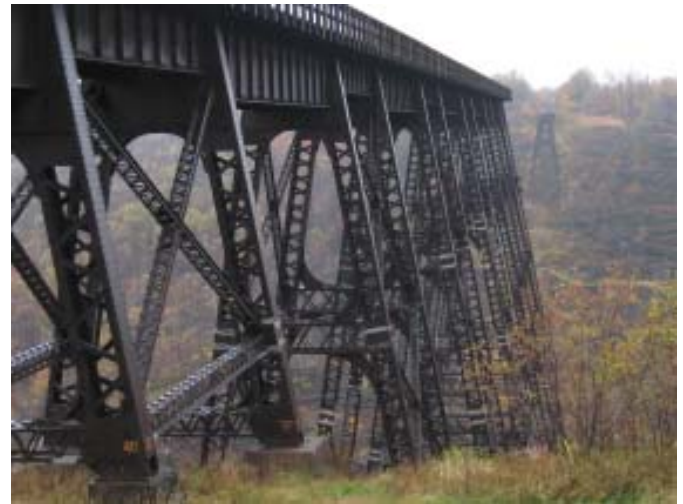
The Kinzua Viaduct — October 2004

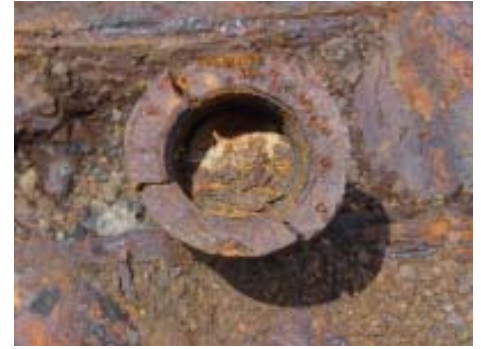
been originally built at the exact same geometric configuration in 1882. Roller-bearing collar-coupling assemblies were constructed to attach the new structure to these existing bolts, as they were too short for the newer design. By examining these collar-coupling assemblies at the site, it was evident that they were all corroded, and many were critically fractured previous to July 2003. The site observation that failure occurred at this interface at every failed tower confirmed two things — the Board's theory of the mechanism of collapse, and the assumption of the anchor bolts as the structural system's weak link.

Subsequent to the field view, the Board performed a series of laboratory metallurgical tests on the anchor bolts and collar-coupling assemblies. What was observed was a series of distensions in the crystalline iron structure of the elements indicating not only tensile overstress, but also evidence of excessive cyclical fatigue stresses. These markers indicated that the majority of the structural damage to these elements had occurred, not

Fractured collar-coupling assembly

during the storm event, but during the previous 102 years, under the constant cyclical loading of wind and trains.

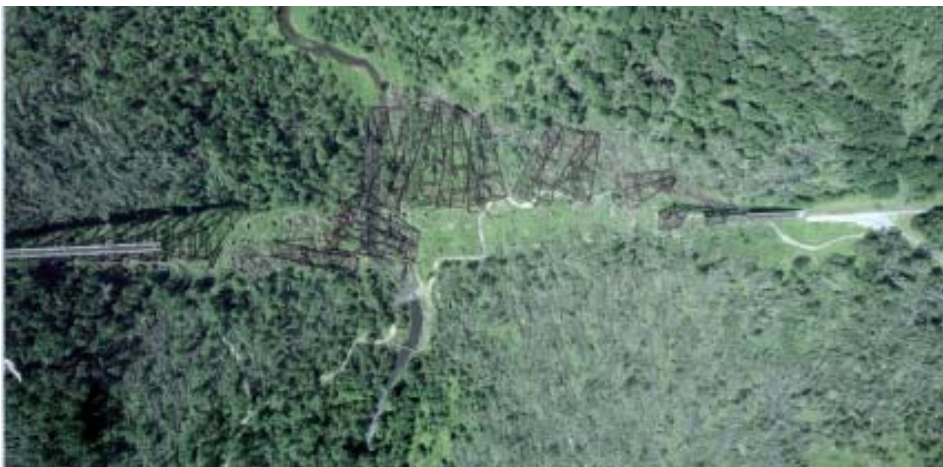
The direction of both tree trunk debris and the collapsed towers at the Kinzua site led the forensic team to determine that the direction of wind and, ultimately, a structural “weak link” were responsible for the bridge’s collapse. By viewing aerial photography of the site, two distinct paths of wind attack were evident. First, tangential winds emanating directly from the tornado’s vortex impinged the structure from the east. Next, strong inflow winds, which fed the tornado, attacked

Aerial photography of the Kinzua site was crucial in determining the cause and order of collapse
